Replacing Dometic Heat Pump on 2002 190 Versatile

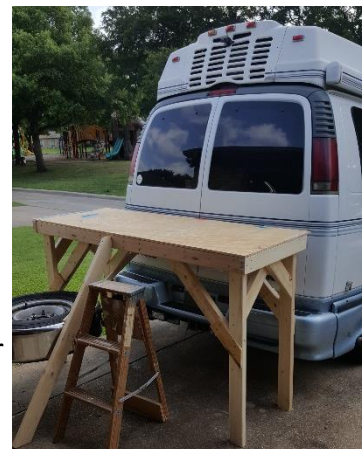
careful to make the platform level and very sturdy. The overall height is about 45 inches. It felt a little tippy when leaning over the top of the unit, so I added the outrigger. I'm not going to provide any more information on the platform.

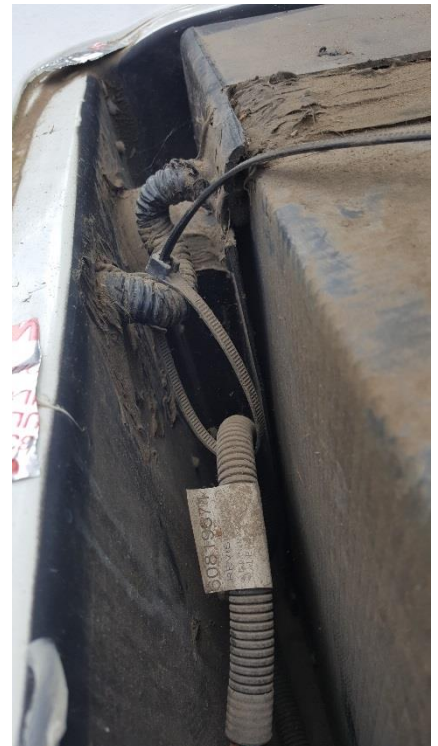
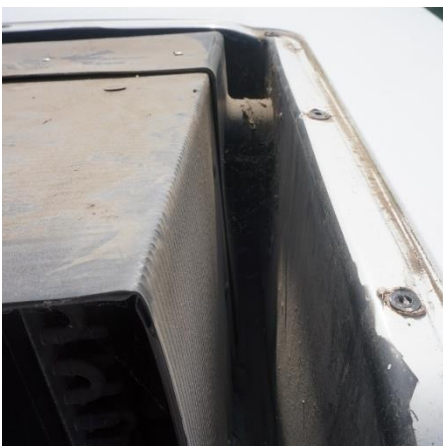
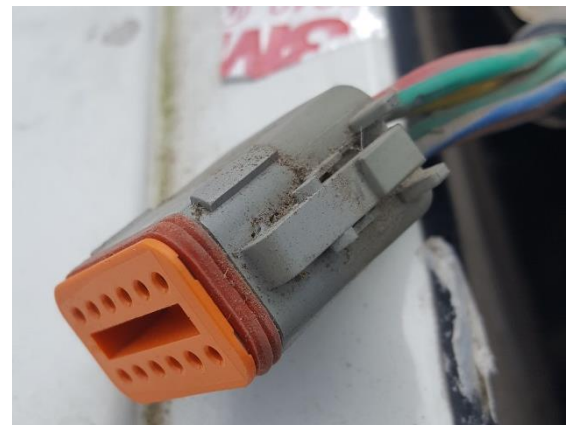
With the shroud off, I took a close look at what I had and took some pictures. On the left side the 120-volt power is routed to a common electrical box with the cover facing upwards. It was covered in black sealant. I noted the tie wrap which is holding up the control cable. This I believe was done to keep the connector from resting in the bottom in a puddle of water. The connector is well-made with retainers and a gasket. The right side of the unit was just open with no wires. Note the round duct which directs cold air to one of the two registers on the ceiling below the unit. There is an identical duct on the left side. It's a little hard to see in the picture with the wiring in front of it.

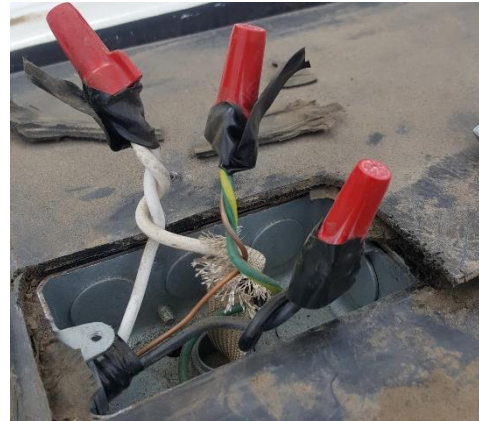
There are two electrical connections to the unit. The first is the 120-volt AC connection and this is routed via a short harness from the left side into a very standard metal electrical box bolted to the left side of the unit. I easily peeled off the sealant and removed the cover exposing the wires. The Roadtrek wires are solid conductors and the unit has stranded conductors. Roadtrek seems to commonly add tape to the wire nuts. I don't know if this keeps water out or prevents the nuts from backing out due to vibration. I simply unplugged the control connector. It was tight and I found it difficult to compress the release tabs.

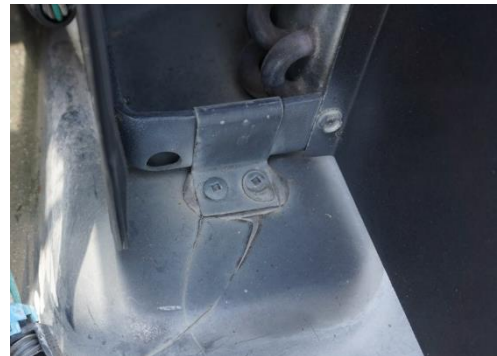
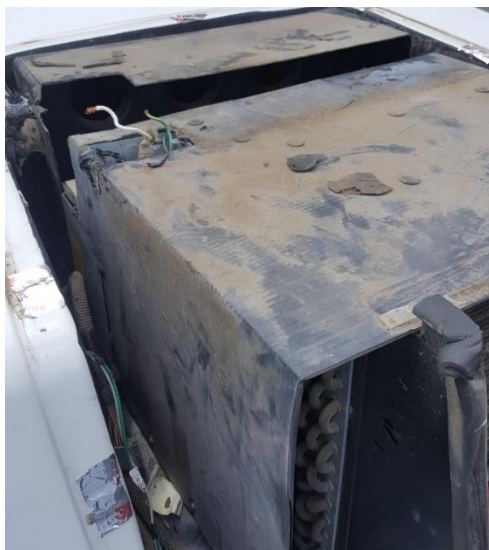
The only thing holding this unit in place are two clips on either side of the unit. These are held in place with two screws each. There was a bit of the same black sealant under each clip. There were 4 sheet metal screws which went through the plenum. The seam between the plenum and the unit was not sealed. I just rocked the unit left to right and it came loose easily.

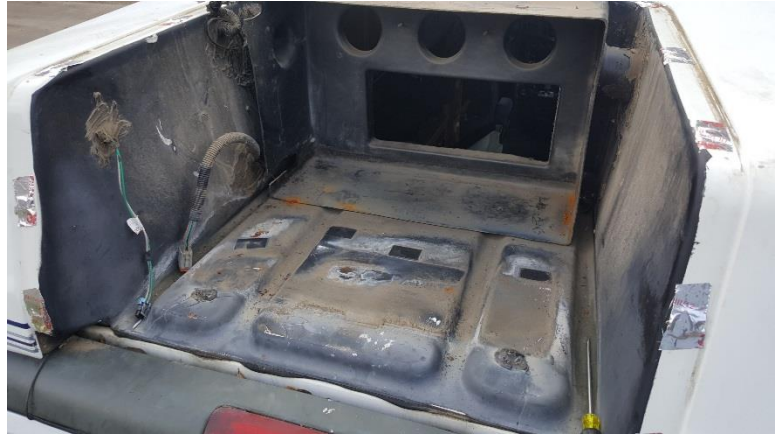
With the unit out you can see the inlet air window and the two side ports which feed air to the registers on the ceiling below. I'm not certain but the bottom looks like part of the original van roof which was not cut away.

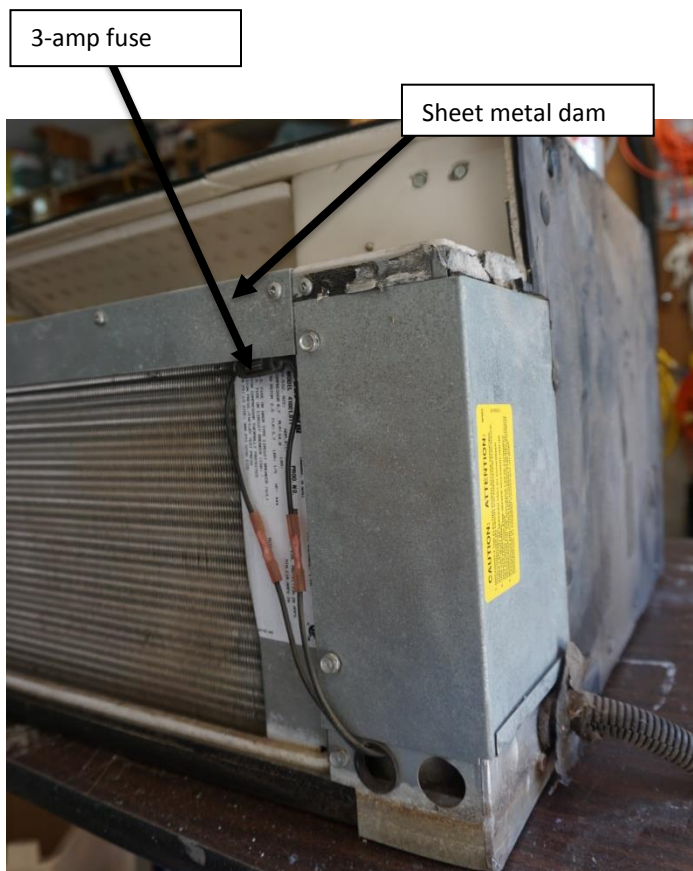
There are some baffles which Roadtrek added to the unit both on the front and the back. On the front is a piece which dams or blocks air from leaking from the inlet to the outlet. It's attached with a few self-drilling sheet metal screws. A little caution is in order here installing this on the new unit. If the drill were to slip you might damage the coils.

There was also a 3-amp low voltage fuse holder and fuse tucked up behind the dam. I had thought this was a sensor.

Notice the discoloration on the lower right due to water collecting here.

I don't have a picture, but the new unit has some baffles on the back which direct the hot air out the back and keep it from recycling into the inlet. I had to move the Roadtrek provided baffles on the back to the new unit. Unfortunately, the mounting holes did not match up exactly, so it was necessary elongate the existing holes both top and bottom to make them fit. There are some rubber seals on the edge of the baffles which were in good shape. The one across the top was glued in place and I replaced it with some foam weather-stripping.

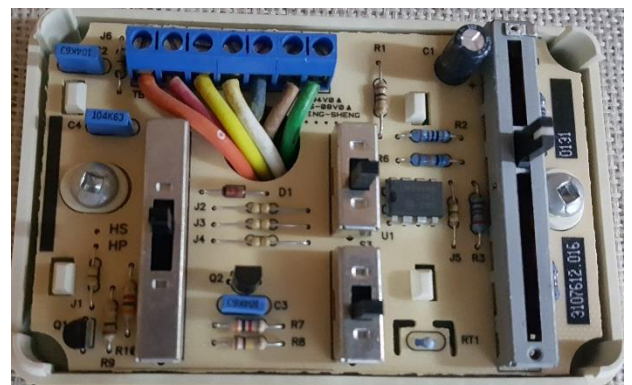
Existing Thermostat

The 120-volt AC connections are the same as the old unit, but the control logic is entirely different. There were separate lines to control the fan, compressor etc. The new unit has a 3-wire interface to the thermostat. One wire powers the thermostat, one is a ground return and the third is the serial communications channel. The wires were nicely labeled in the box. There is an identified wire for the power to the thermostat and this is not connected directly to the 12-volt inlet. Not too difficult, one just needs to secure the unused wires and make note of the one used for the serial interface. I temporarily ran the unit on the bench to make sure everything worked before installing the unit into the trek.

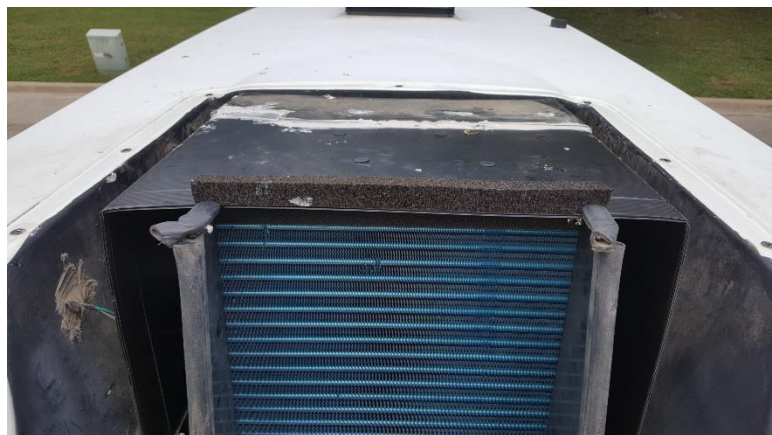
While not extremely heavy, it was very helpful having an assistant help lift the unit into place. Before lifting it up I will point out that there are stick on rubber isolation blocks on the bottom of both the original unit and the new unit. There is a step in the pan towards the front of the unit and there were two blocks not on the old unit. I had to remove these because it made the unit too high to fit.

I was able to push the unit into place and reconnect the wires. Before securing the unit in place I made sure everything worked. Had a minor hiccup since I was not able to make the furnace come on. It was too hot! Letting the new AC run for a few minutes solved that problem.

I replaced the clips on the unit and the 4 screws in the plenum. I sealed the seams with some silicone caulk. I did not attempt to seal the bottom; this would make it very difficult to remove.
